CE 454

Pavement Maintenance and Rehabilitation Term Project

The road section between Migros and Çankaya University, 100.Yıl, Çankaya is selected to perform maintenance and rehabilitation study.

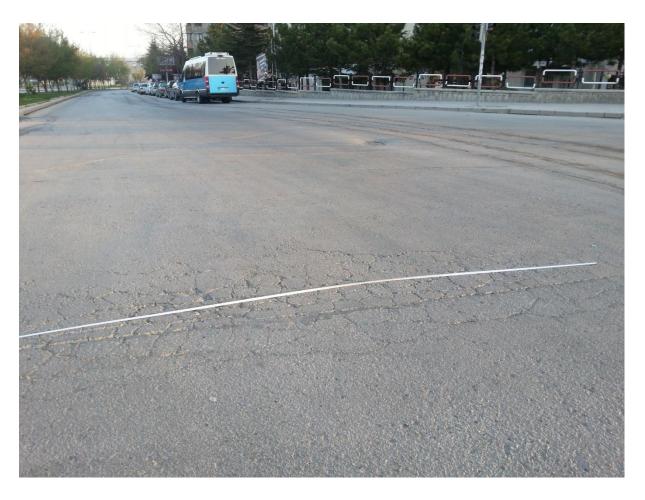
Figure 4 - Transverse Cracks

<u>**Transverse Cracks:**</u> In the observation, we specified high severity (30 mm spacing) transverse cracks. This type of distress is generally temperature-related and when we take the region climate into consideration, high temperature difference is a possible cause. Therefore, we can also call these cracks as thermal cracks.

Transverse Cracking

- 1. Remove and replace the cracked pavement layer with an overlay.
- 2. Crack sealing
- 3. Seal Coat
- 4. Unusual soil properties minimize reflection cracking
- 5. Asphalt-rubber membrane with thin overlay
- 6. Heater-scarification/milling with thin overlay

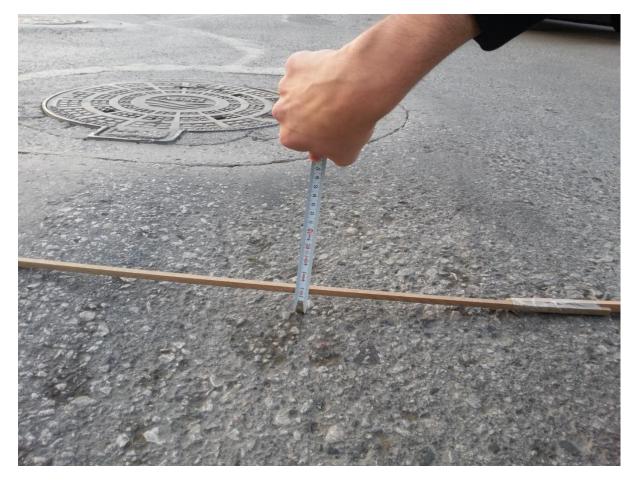
Figure 5 - Rutting

<u>Rutting</u>: In the observation, we specified some low severity (around 3 cm) rutting examples from place to place. Generally, this type of distress is load-related. However, the selected road section is rarely used by heavy vehicles like trucks and this changes our prediction to other possible causes like consolidation of sub-layers or subgrade, insufficient design thickness, lack of compaction during construction or weak asphalt mixtures. A detailed survey including tests may give us the correct cause but due to lack of equipment and the fact that it is not observed along the whole road, we assume that it is caused by local settlement of sub-layers or subgrade.

- 1. Cold milling including profile requirements with or without overlay
- 2. Heater scarification or milling with overlay
- 3. Replacement

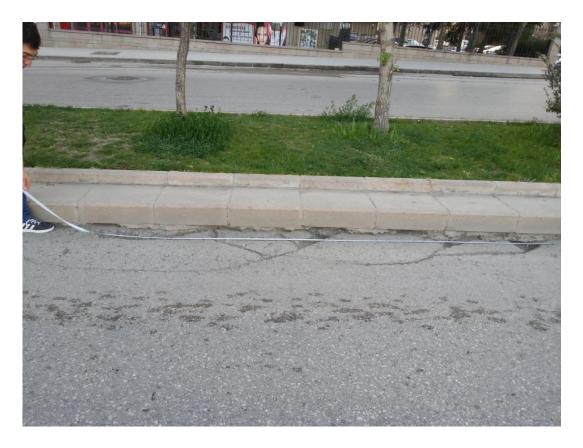
Figure 6 - Edge Cracks

Edge Cracking: In the observation, we specified edge cracks along almost whole road section. The widths of cracks are changing from space to space. In the current circumstance, edge cracks are not disturbing the driving comfort since they are limited in a narrow area. However, if necessary rehabilitation is not applied, they may propagate through the mid-sections of lanes. There are several possible causes of edge cracks like lack of lateral support, settlement of underlying material, weak base or subgrade, frost heave and heavy traffic etc. However, when we consider both condition and usage of the road, poor drainage system is the most likely cause of those cracks.

Along the almost whole road edge crackings are observed. In order to rehabilitate the distress, we should first identify possible cause of problem. Edge cracking has different causes such as, lack of adequate drainage system, lack of lateral support, frost heave, weak base or subgrade soil, heavy traffic or vegetation along the edge and settlement of underlying soil. In our road section, reason is most likely combination of lack of adequate drainage and frost heave. Due to lack of drainage system, water, on the surface accumulates at the edges and it damages surface of road. In the winter time with the low temperature accumulated water freezes in cracks and it enlarges cracks in all directions.

As a result, we suggest improving drainage system as a rehabilitation technique.

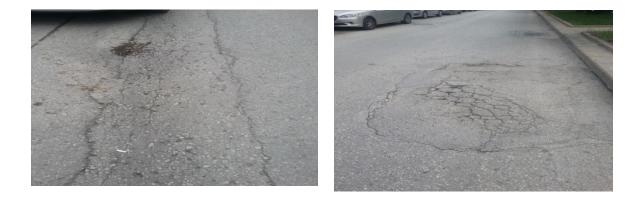
Fatigue Cracking: In the observation, we specified fatigue cracking in longitudinal direction with low to moderate severity. Possible and most likely causes are excessive loading, weak or thin surface or base and poor drainage. These cracks are generally observed along the parking lanes and sections where patching is applied.

Figure 7 – Low Severity Fatigue Cracks

Figure 8 – Moderate Severity Fatigue Cracks

In our road section, fatigue cracks are high severity, however they are not widespread to perform HMA overlay over entire pavement surface. Instead, it is logical to dig out crack section then replace the area of poor subgrade and improve drainage of that area and finally patch over the repaired subgrade.

As a result, we suggest partial improvement of subgrade of crack region and patching of improved subgrade.

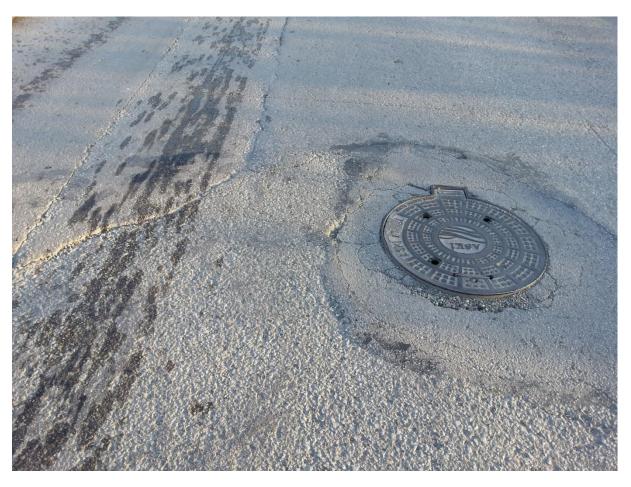
Patch Deterioration / Utility Cuts: In the observation, we specified plenty of these kinds of distresses at moderate severity. The most likely cause is poor installation techniques like inadequate compaction, inferior or improper material usage. Since there are a number of high severity level these distresses, they are one of the major breakdowns along the road section that decreases the driving quality.

Figure 9 - Moderate Severity Patch Deterioration

In our road section, we specied plenty of patch deterioration. There are several possible causes of this distress type. Poor intallation techniques like inadequate compaction, inferior or improper material usage and failure of the surrounding or underlying material are alternatives. In our case, the most probable cause is poor installation techniques. The reason for this is poor foundation or sub-base related distresses were not observed widely along the road. In the literature, there is only one suggested rehabilitation technique for this type of distress and it is replacement of patch with deep or full-depth patch.

1. Replacement of patch with deeper patch

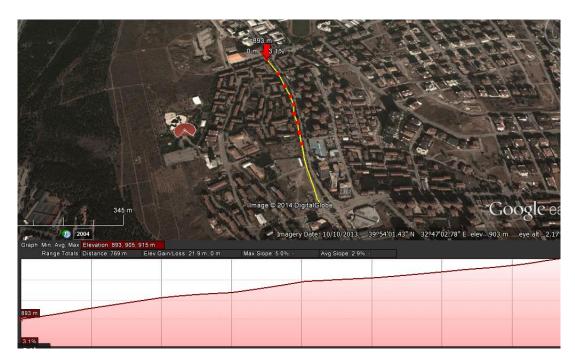
Figure 14 – Pavement Slope

Beyond these questions, if the slope of the pavement discussed, along the slope of the road (longitudinal direction) is 2.9% as average and 5% as maximum. These values is not too bad to direct water path. For transverse direction, it is observed that the water in the middle of the pavement is delivered to edges.
